## TECHNICAL INFORMATION

**E. Title :** L8180 Series/ET-8550 Series Abnormal Sound and Paper feeding problem on R-ASF

ET-8500 / ET-8550 / L8160 / L8168 / L8180 / L8188

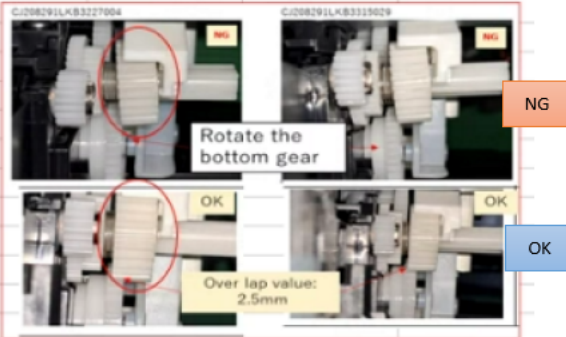
Fig.1 SPUR GER,22.4

One of the causes was that the inner diameter rib of the gear opened toward the outer circumference due to the shrinkage effect during part molding (this is out of spec). This results in a tilt.

Changed the mold structure to assume opening due to shrinkage (adding a taper assuming opening)

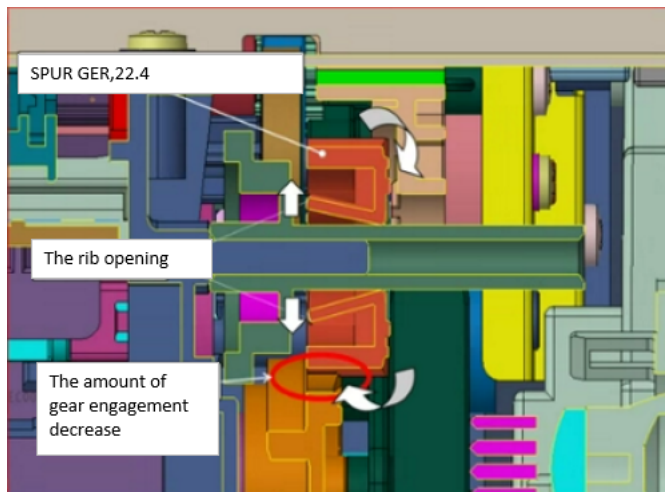
(Direct cause) The amount of gear(SPUR GER,22.4 of D/E) engagement is not enough

Fig.2 Comparison of OK and NG on the amount of gear(SPUR GER,22.4 of D/E) engagement
