## TECHNICAL INFORMATION

**E. Title :** L8180 Series/ET-8550 Series Abnormal Sound and Paper feeding problem on R-ASF

ET-8500 / ET-8550 / L8160 / L8168 / L8180 / L8188

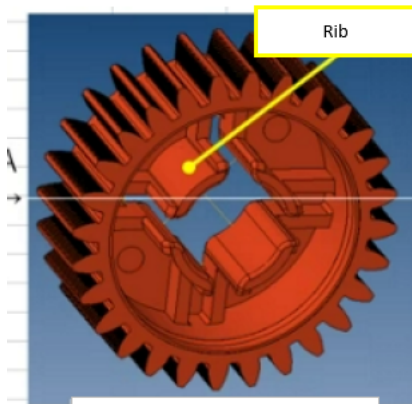
Fig.1 SPUR GER,22.4

(Direct cause) The amount of gear(SPUR GER,22.4 of D/E) engagement is not enough

(Root cause) Several reasons are assumed.

One of the causes was that the inner diameter rib of the gear opened toward the outer circumference due to the shrinkage effect during part molding (this is out of spec). This results in a tilt.

Please refer attached file regarding the replacement procedure for SPUR GER,22.4.
